MICROCHIP PIC18F2423/2523/4423/4523

PIC18F2423/2523/4423/4523 Rev. B2 Silicon Errata

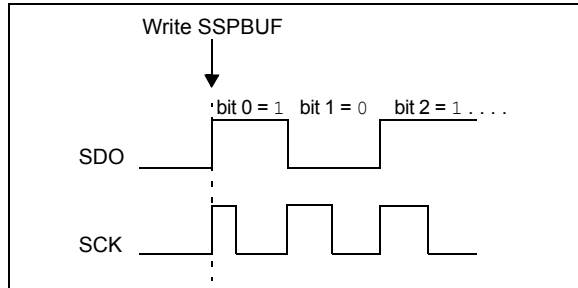
FIGURE 1: SCK PULSE VARIATION USING TIMER2/2

When the SPI is using Timer2/2 as the clock source, a shorter than expected SCK pulse may occur on the first bit of the transmitted/received data (Figure 1).

To avoid producing the short pulse, turn off Timer2 and clear the TMR2 register, load the SSPBUF with the data to transmit and then turn Timer2 back on. Refer to Example 2 for sample code.
